## A Survey of Thatched Buildings in Scotland

Thatch Survey of Scotland  
2014-15

A photographic survey of thatched buildings in Scotland, surveyed between May 2014 and August 2015 by Zoe Herbert (SPAB Scotland Officer), on behalf of the Society for the Protection of Ancient Buildings.

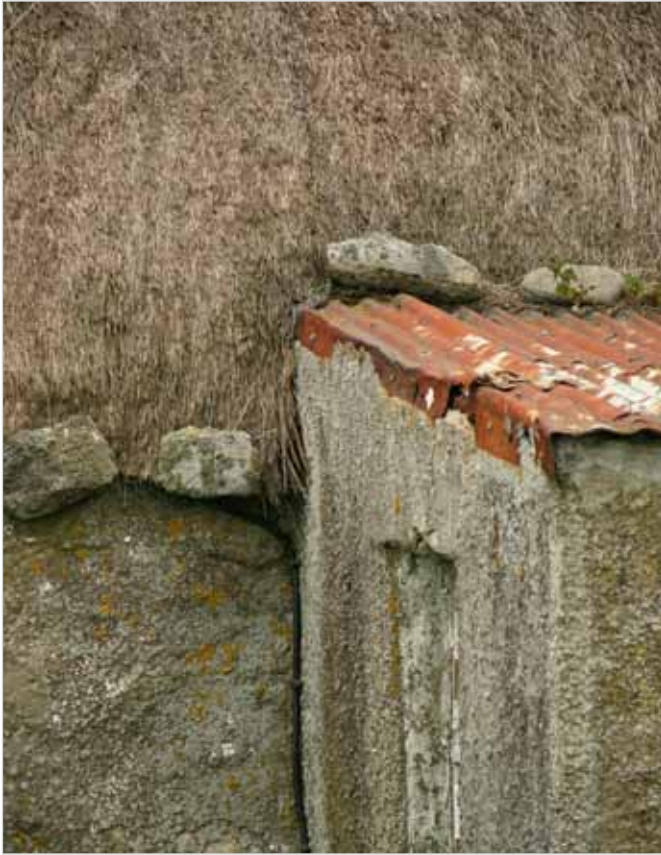
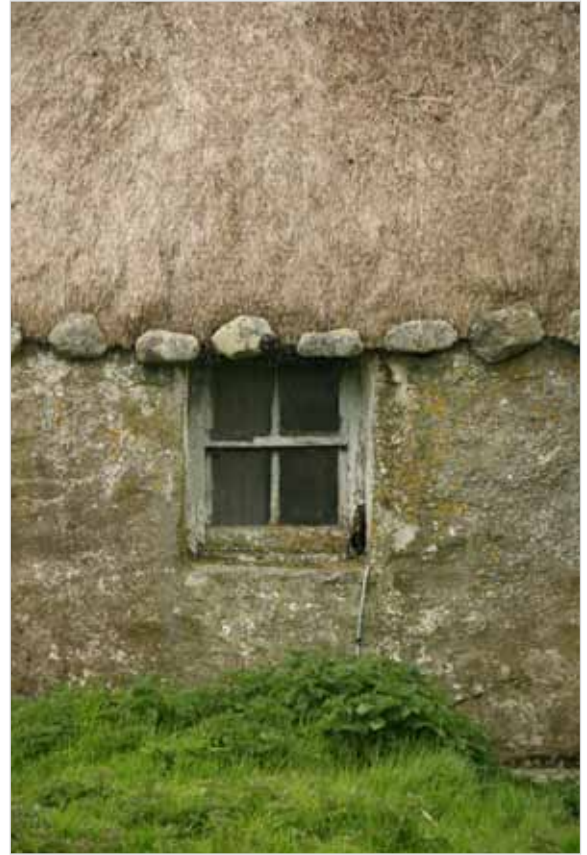
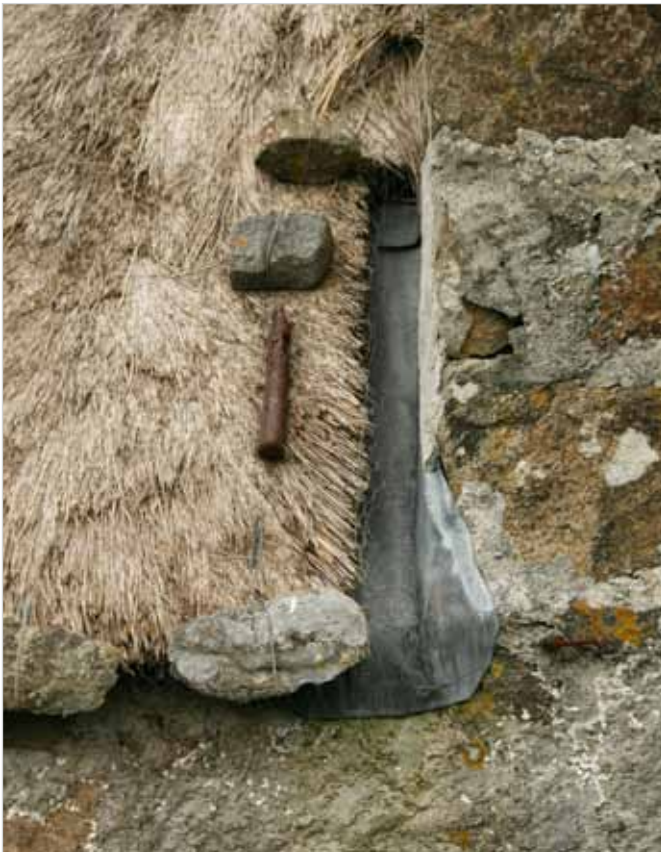
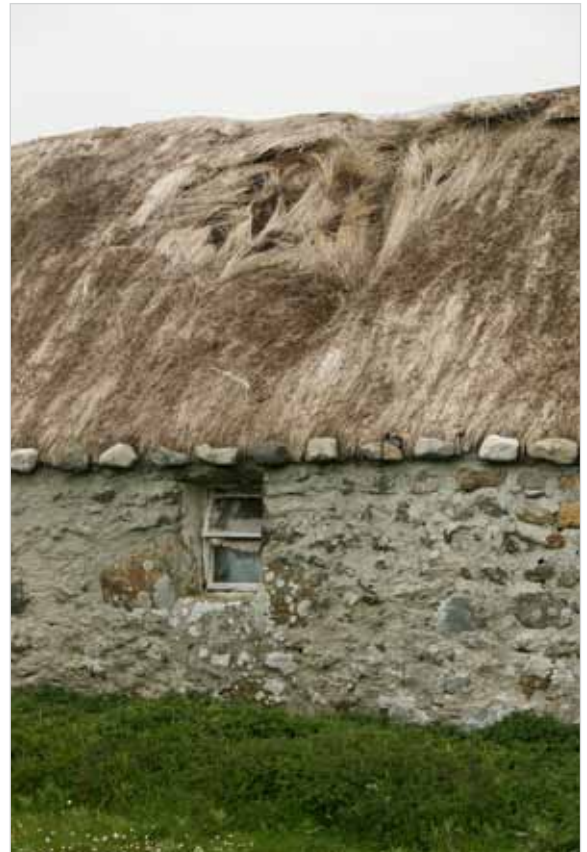
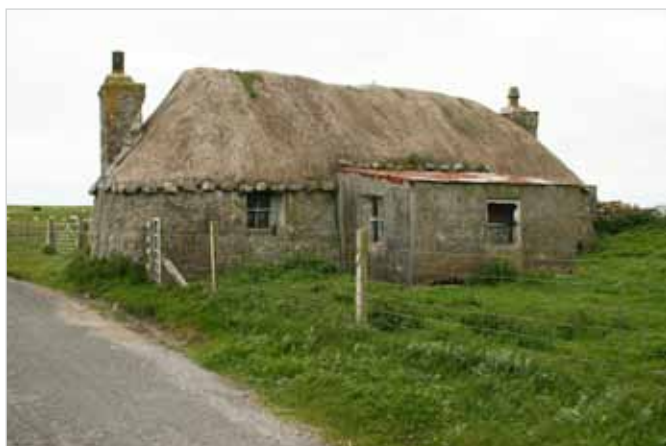
Garrynamonie Thatched Cottage – Western Isles

Condition of Thatch: Poor

**Additional Notes:** Single-storey cottage of unknown date, currently vacant. The roof is thatched in marram and has a continuous marram ridge. The entire roof has been netted, including across the ridge, which is weighted along the eaves and around the chimney stacks with stones, in addition to small metal tubes around the stacks, secured to the netting with wire. There is some missing/deteriorated thatch on the rear elevation of the building. As well as this area of damaged thatch there is a small amount of grassy vegetation growth in places throughout the roof. The condition of the thatch is likely to deteriorate further if the building remains unoccupied.

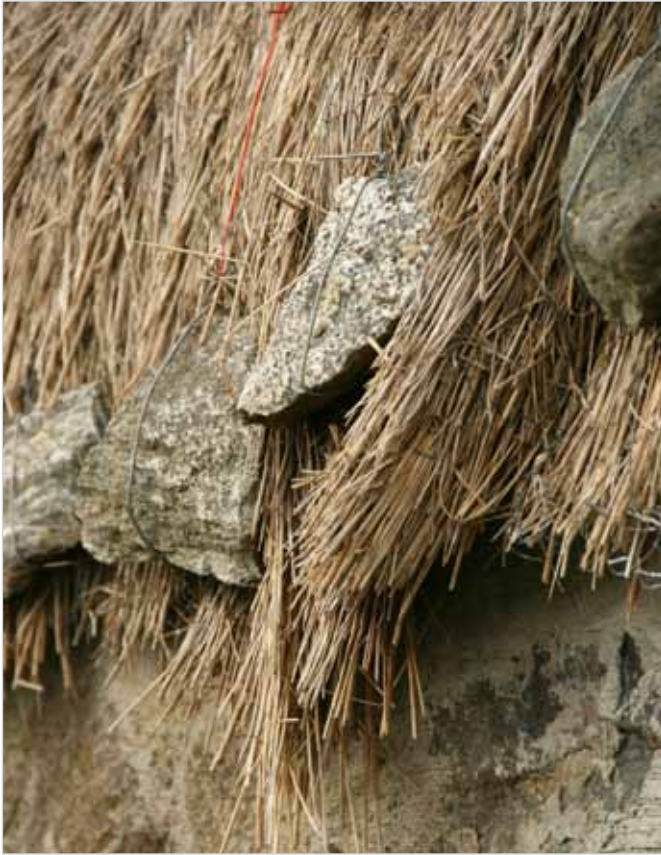
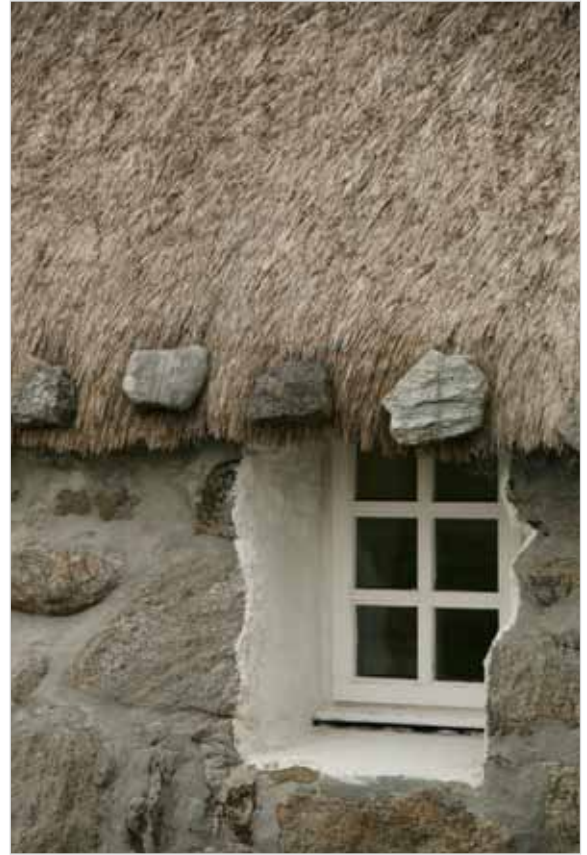
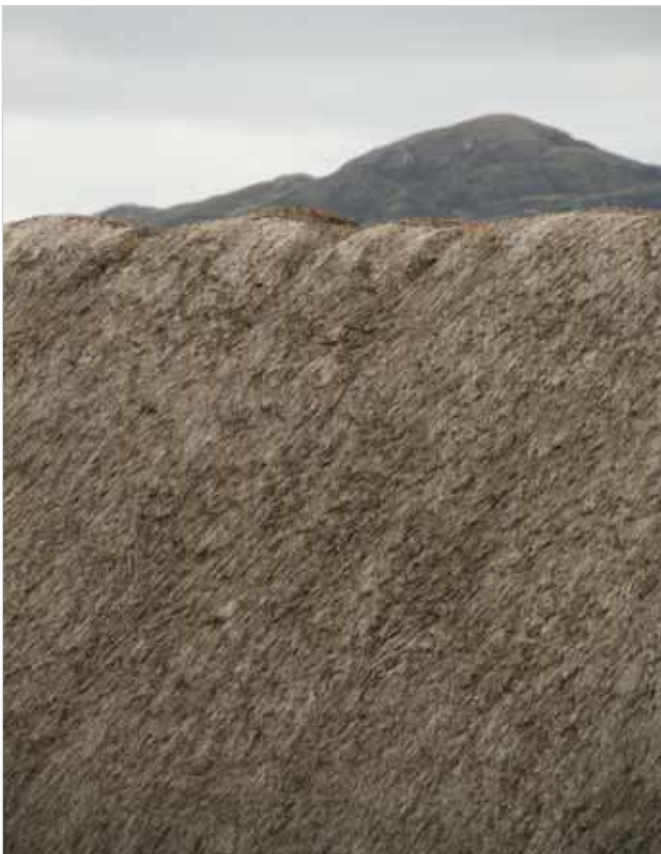
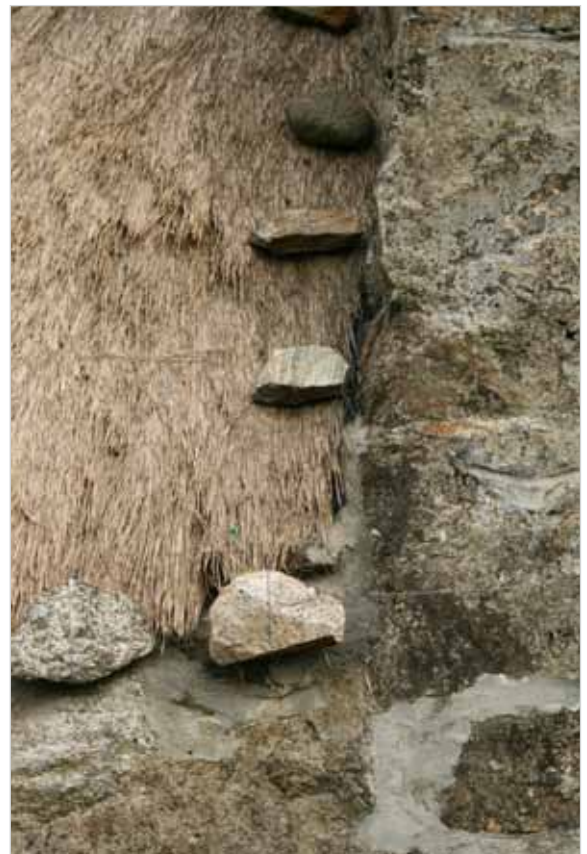
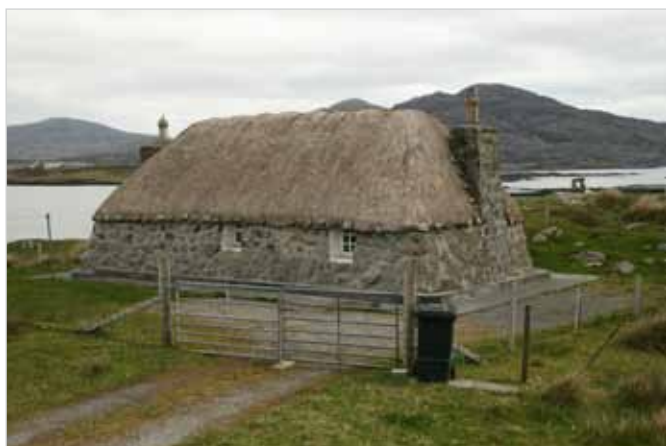
Seann Taigh – Western Isles

..... Thatched (Marram)

..... Good

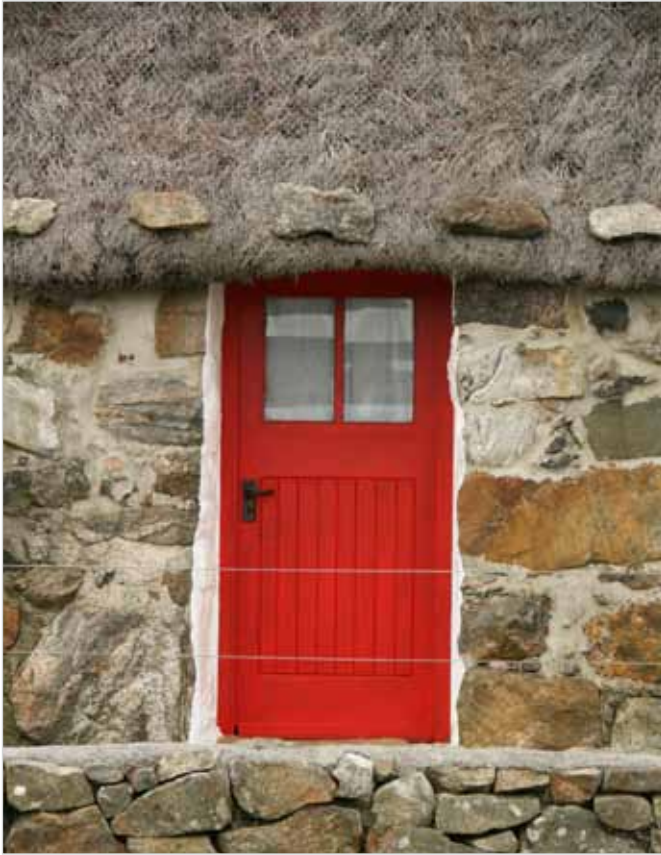
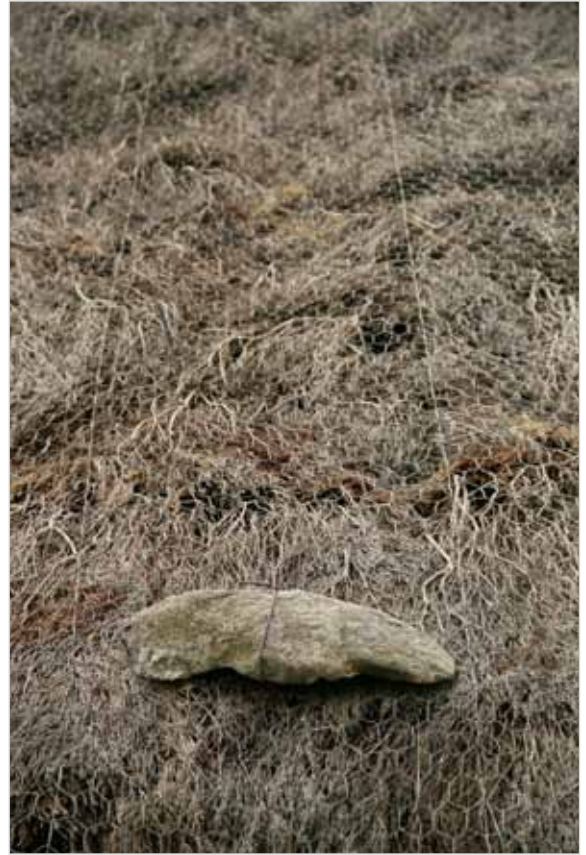
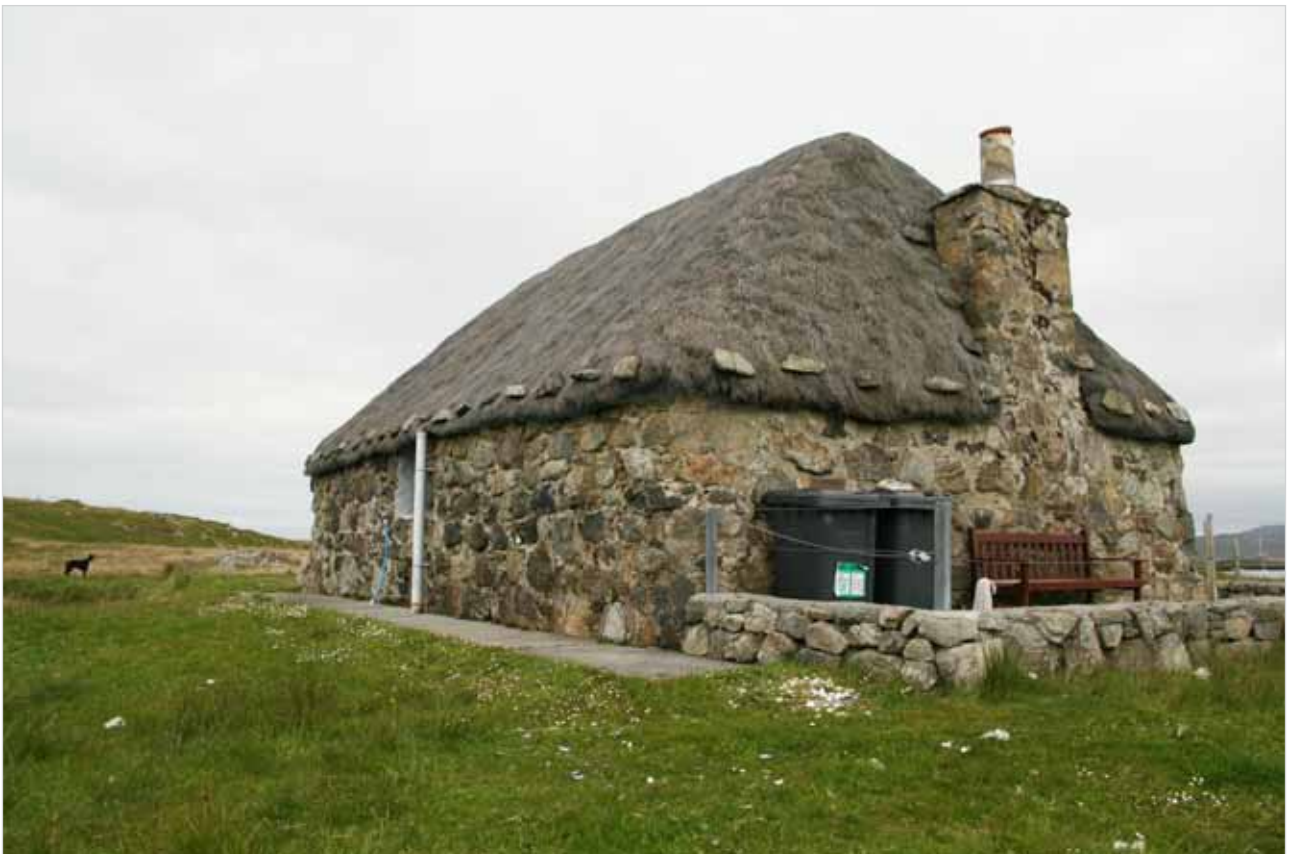
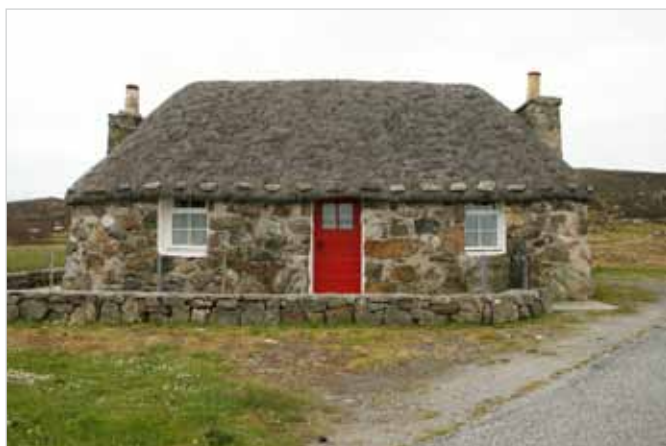
466 South Lochboisdale – Western Isles

Condition of Thatch: ..... Good

Additional Notes: ..... Probably 19th-century single-storey cottage, listed as having a '*muran* thatch roof, secured with ropes and stone weights'. The building has been renovated for use as holiday accommodation and now has a heather-thatch roof with a continuous heather ridge. The entire thatch has been netted, which is weighted at the eaves and around the chimney stacks at either gable end with stones, secured to the netting with wire.

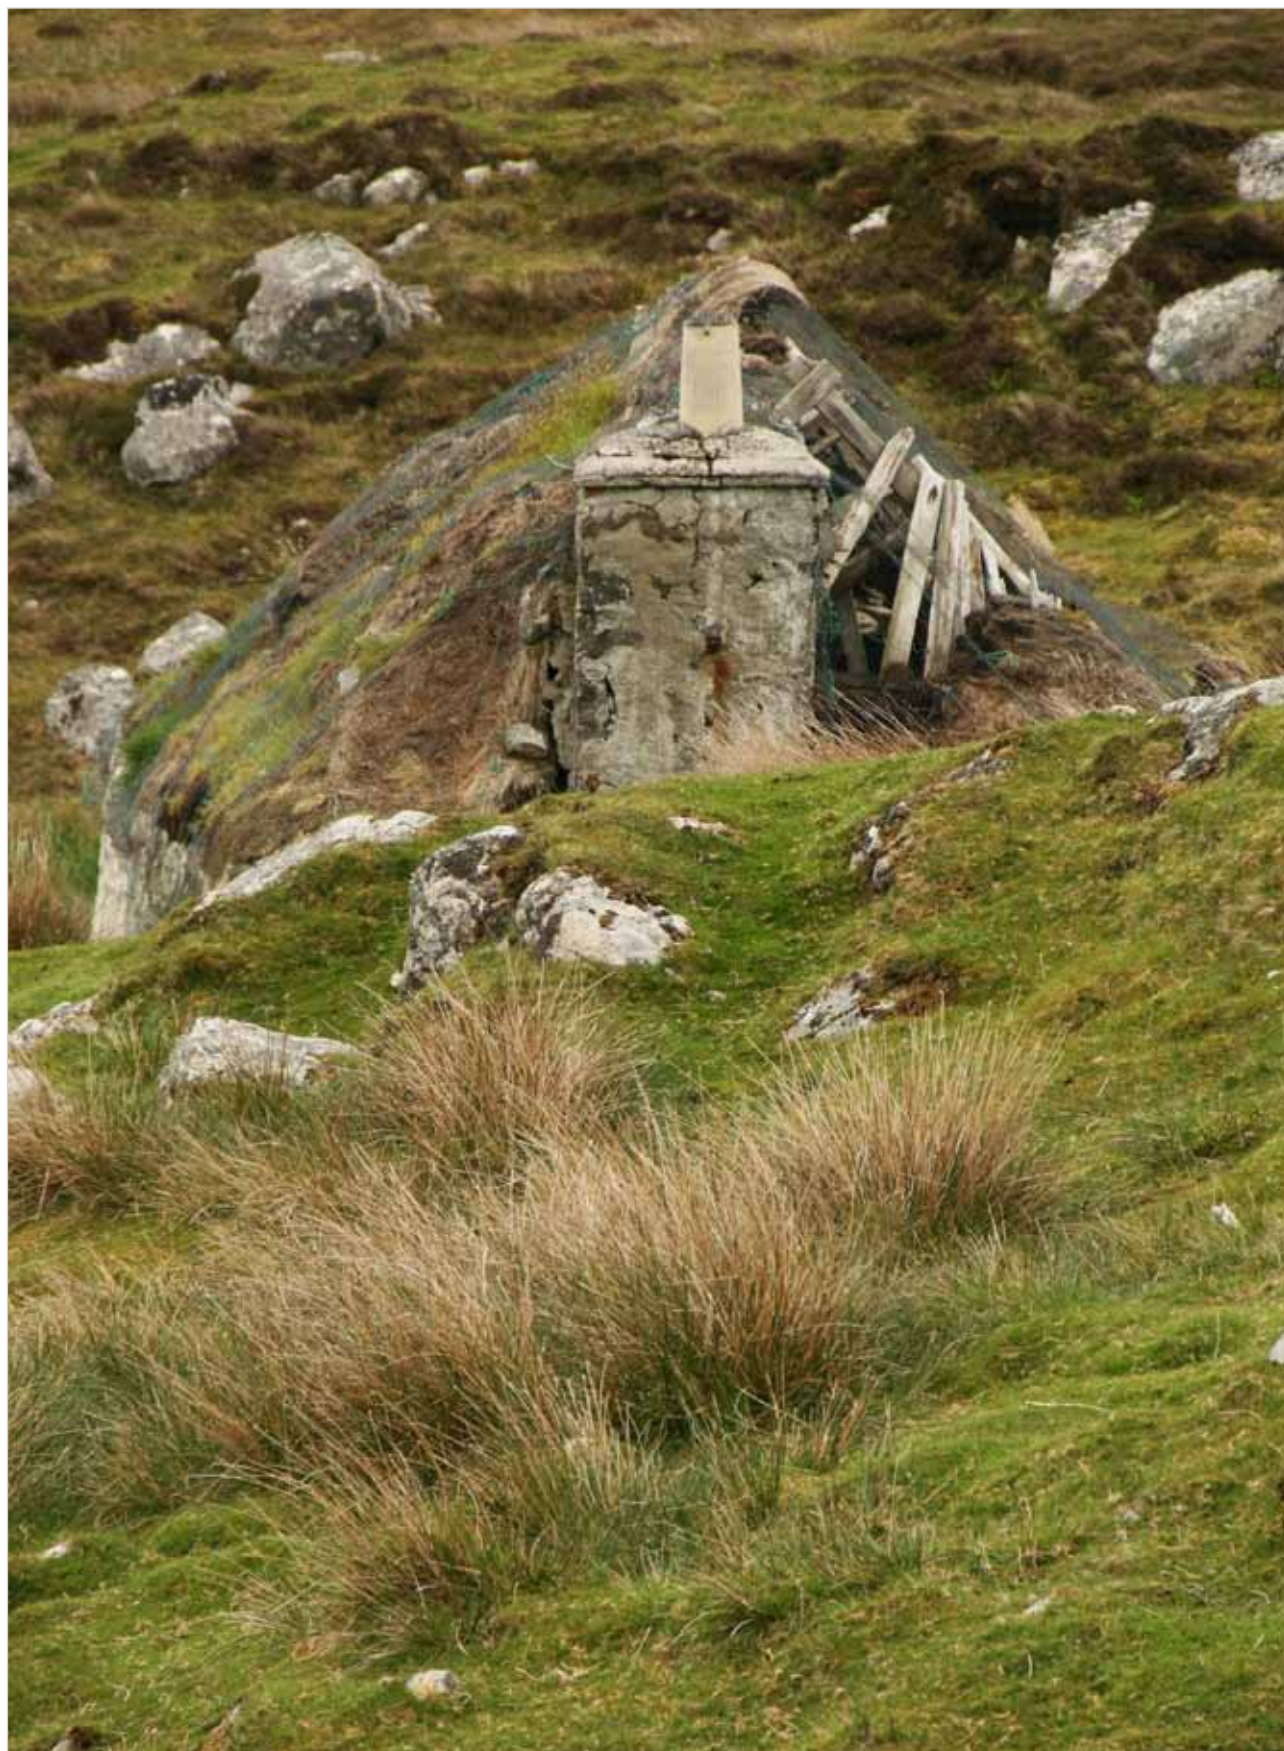
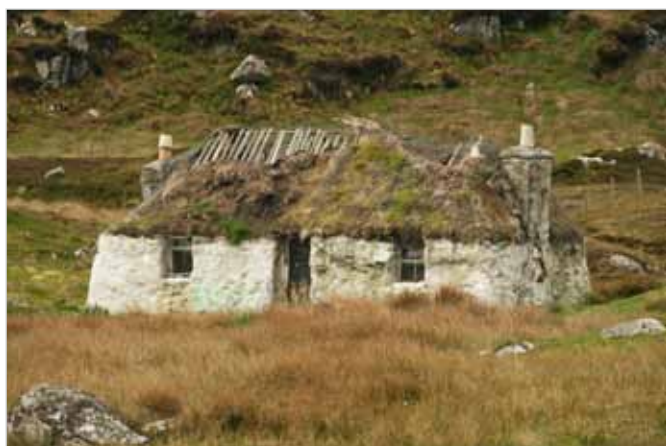
472a South Lochboisdale – Western Isles

Condition of Thatch: ..... Poor

**Additional Notes:** ..... Probably 19th-century cottage is listed as having a 'muran thatch roof, secured with ropes, netting and stone weights'. Large sections of marram thatch are still in place on the building; however, the building is derelict and much of the roofing material has been lost, leaving the interior of the building exposed. The site could not be accessed when visited, yet photographs taken from nearby show visible signs of netting still in place and a few weighting stones left intact around the chimney stacks only. A small section of thatch remaining along the ridge suggests it was thatched continuously across; however, this cannot be determined for certain.

..... The roof appears close to collapse as many of the timber beams can be seen to be damaged. There are large areas of grassy vegetation growth on the surface of the remaining thatch.

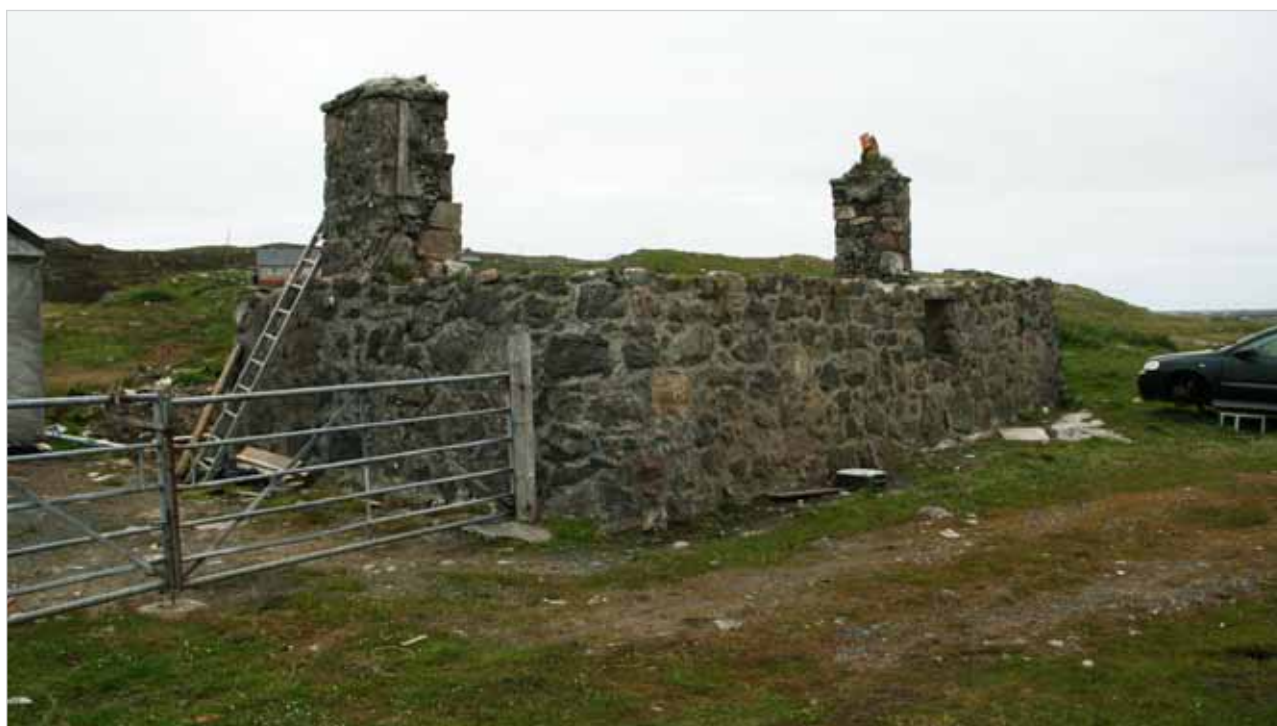
Address: ..... 472b South Lochboisdale

**Additional Notes:** ..... Group listing for a 'Probably 19th century' thatched cottage and 'byre and shed to north and to south also thatched'. The cottage is listed as having a 'muran thatch roof, partly renewed in straw, and secured with netting ropes and stone weights'. There are no visible signs of anything that could clearly be identified as the byre and shed, and the cottage itself is now a roofless ruin with no visible signs of any thatch remaining. The listing description for the building should be updated accordingly.
